# Identification of and Remedial Approaches to Hot Spots

*by Donald K. Stauble and Mark B. Gravens*

**PURPOSE:** This Coastal and Hydraulics Engineering Technical Note (CHETN) provides information about the suspected causes and remedial approaches that have been applied to erosion hot spots on several recent beach nourishment projects. These diverse examples form the basis for general identification and steps that can be taken to mitigate for and anticipate the development of hot spots on beach nourishment shore protection and environmental restoration projects.

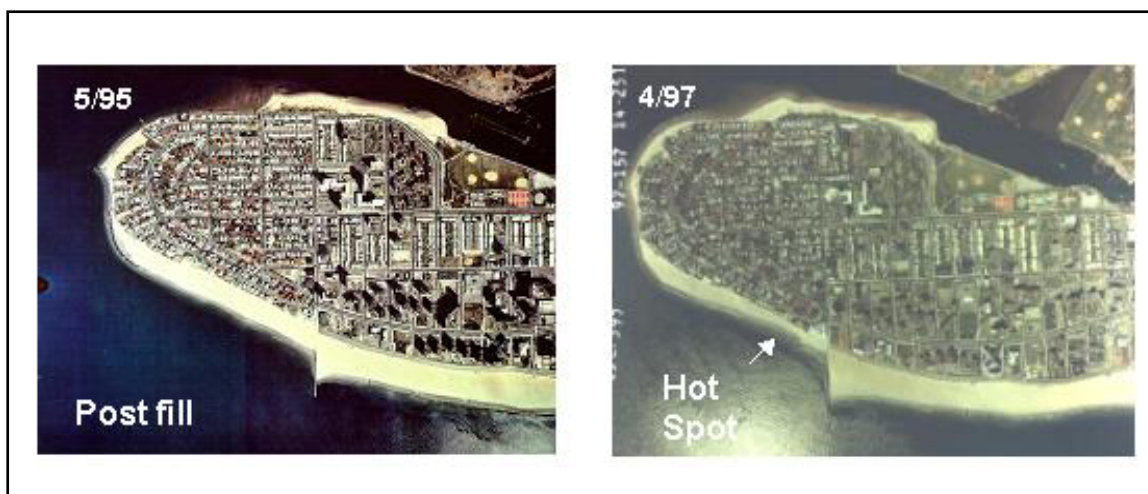
Figure 3. Post-fill March 1995 and 2 years later April 1997 at Sea Gate hot spot

**Coney Island, NY.** Coney Island, the westernmost barrier island on Long Island had its first beach nourishment in 1922-23. The latest U.S. Army Corps of Engineers project placed approximately 1.8 million cu m (2.3 million cu yd) of sand along 5.6 km (3.5 miles) of the beach between June 1994 and January 1995 (Bocamazo and Rahoy 1999). A hot spot developed west of the terminal groin at West 37th Street, at Sea Gate, which is downdrift from the project. Net drift is to the west along this coast. Figure 2 shows the location of the hot spot. Rapid erosion of the Sea Gate fillet was anticipated on the downdrift side of the terminal groin through numerical shoreline change modeling using GENESIS and the hot spot development was identified through profile and air photo analysis. Wave focusing by the East Bank Shoals and interruption of longshore transport by the terminal groin has contributed to the Sea Gate hot spot. Within 2 years of fill placement the hot spot was pronounced (Figure 3). Nearshore wave transformation modeling together with shoreline change modeling provided an indication of rapid sand loss from the Sea Gate fillet. The loss of sand from the Sea Gate beach is most likely from episodic storm events, with no post-storm recovery. Mitigation was performed by trucking approximately 22,938 cu m (30,000 cu yd) of sand from east of the terminal groin and placing it immediately west of the groin. A plan for stabilization through compartmentalization using T-head groin structures is being developed for a long-term solution at the Sea Gate hot spot. A 10-year renourishment schedule is planned with annual fill monitoring.

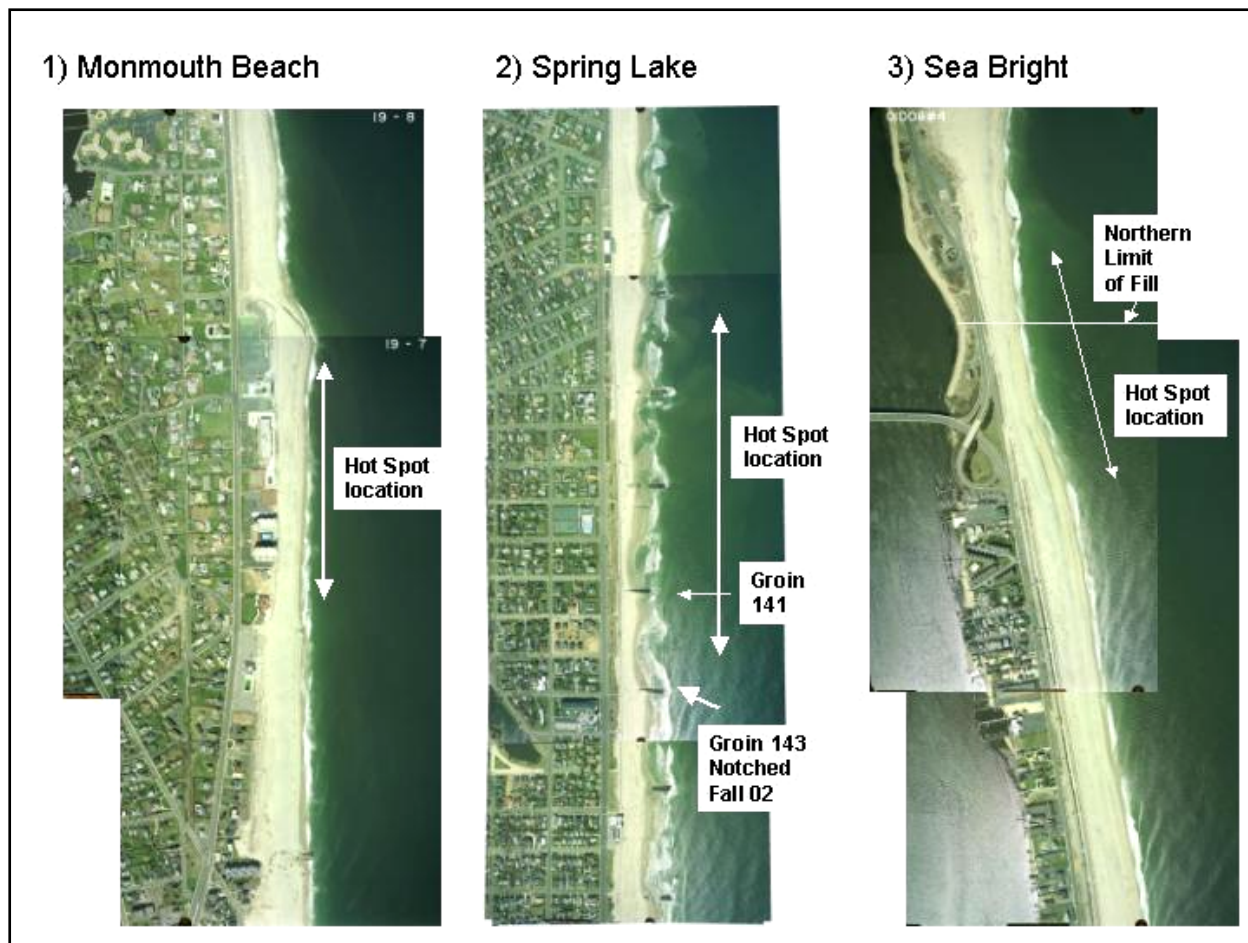
Figure 5. Hot spot locations of Sea Bright to Manasquan Inlet Project (courtesy of Lynn Bocamazo, New York District)

Hot spot 1 at Monmouth Beach was located at the southern boundary of the first contract reach and covered a 793-m (2,600-ft) section of contract area. The initial fill was placed in November 1994 with 396,827 cu m (519,000 cu yd) placed. To mitigate for the erosion experienced at this hot spot, a second placement occurred in November 1995 with 175,858 cu m (230,000 cu yd) placed. A third placement was needed in May 1998 with 431,234 cu m (564,000 cu yd) of fill placed. Through monitoring and analysis it was determined that the cause was seaward perturbation of the beach due to encroachment of the upland structures onto the beach and the design requirement of a uniform

30-m (100-ft) berm width (Figure 5). This area was also at the southern end of Reach 1A and end losses were suspected as a contributor to loss of fill material. This hot spot was resolved with the addition of fill to the south with placement in the next Reach 2 making the beach planform more uniform along the entire reach and the new fill provided an updrift source of sand for the hot spot (net drift is north along this part of the New Jersey coast). The hot spot area was again renourished in September and October 2002 as planned and will continue to be monitored to assess the behavior of this hot spot.

The second hot spot at Spring Lake was located within a groin compartment along a stretch of beach with a groin field. Initial fill was placed between April and October 1997. A visible difference in erosion rates was noticed by the following spring, 610 m (2,000 ft) north of groin 143. To investigate the hot spot, beach profiles and sediment monitoring were increased in this area, and numerical modeling of surf zone hydrodynamics conducted. Construction details were reviewed and a change from one borrow area to another was noted during construction in this area. The wave climate and storm history was also examined for the period after fill placement. The groin length/spacing ratio was examined and groin notching was considered as an alternative to enhance longshore transport and restore the flow of sediments between groin compartments. A determination of causes indicated that the cross-shore adjustment started immediately after fill placement. The average grain size in the erosive hot spot area was smaller than in groin compartments to the south due to the change in borrow areas. Groin 143 should have been notched, because it was trapping too much material.

Groin 141 was determined to be too short and was not retaining enough material. There was also an anomaly in the bathymetric contours offshore of the eroding area, which lead to higher energy dissipation in the center of the eroding groin cell hot spot area. To remedy the hot spot, several alternatives were proposed, but the State of New Jersey wanted the least effort alternative. This consisted of placing 174,329 cu m (228,000 cu yd) of coarser fill material in the hot spot area north of groin 143 in July 2002 and notching the groin in the fall of 2002 (Figure 5). No conclusions have been reached yet on how well notching and larger grain size material is working to remedy the hot spot.

The third hot spot related to this project was located at the northern end of the town of Sea Bright just at the boundary with the Gateway national recreation area at the base of Sandy Hook. This part of the project was initially filled between July and November 1995 and again between May and November 1996. This area is the north end of the entire project. Monitoring profiles were examined but no additional investigations were carried out. Monitoring data indicated that the fill material is drifting north out of the fill limit into the recreation area (Figure 5). Renourishment material was placed in this area to mitigate for the hot spot in September 2002. No conclusion has been made at this time on the success of this renourishment and monitoring will continue.

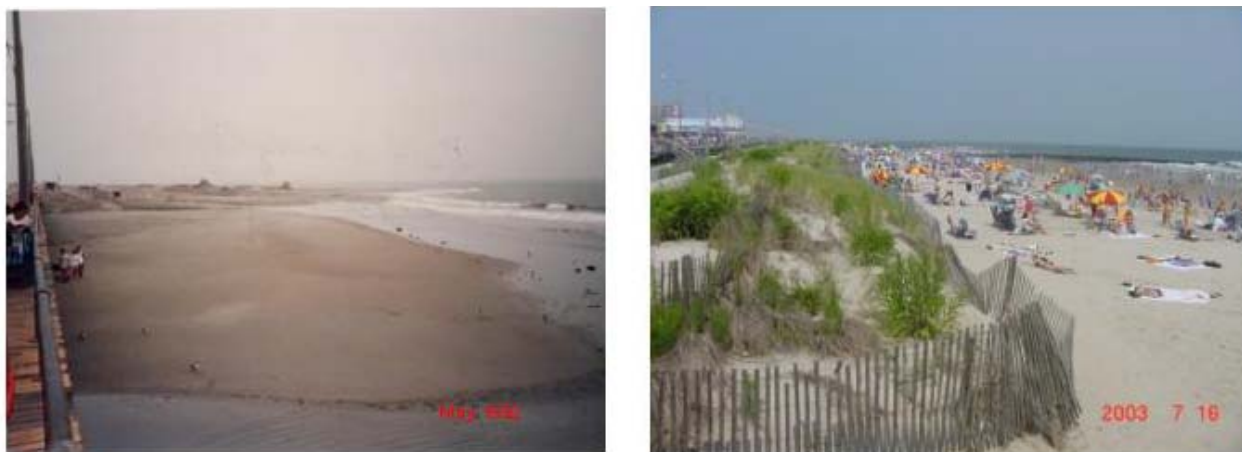
Figure 7. View of Ocean City, NJ, hot spot area during initial fill placement (May 1992) and in July 2003 showing constructed dune and berm after 11 years and five renourishments

Remedial actions taken include overfilling of the hot spot area in the 1995 and 1997 fills. Scarps formed on the beach as the sand readjusted after fill placement. The design template was redesigned with a lower design berm from 2.67 to 2.21 m (8.75 to 7.25 ft) North American Vertical Datum (NAVD) and a small dune feature was added to the profile for storm protection in the hot spot area only (Figure 7). A new renourishment will take place in the fall of 2003 focusing on the beach area around the hot spot. Other possible remedial actions could be to modify the borrow area dredging location to move it further offshore within the borrow area and to dredge the Ocean City side of the Great Egg Harbor Inlet navigation channel, which is migrating northeast (updrift direction) and narrowing as inlet circulation evolves. No damage to upland structures or boardwalk has occurred since the 1992 nourishment project construction.

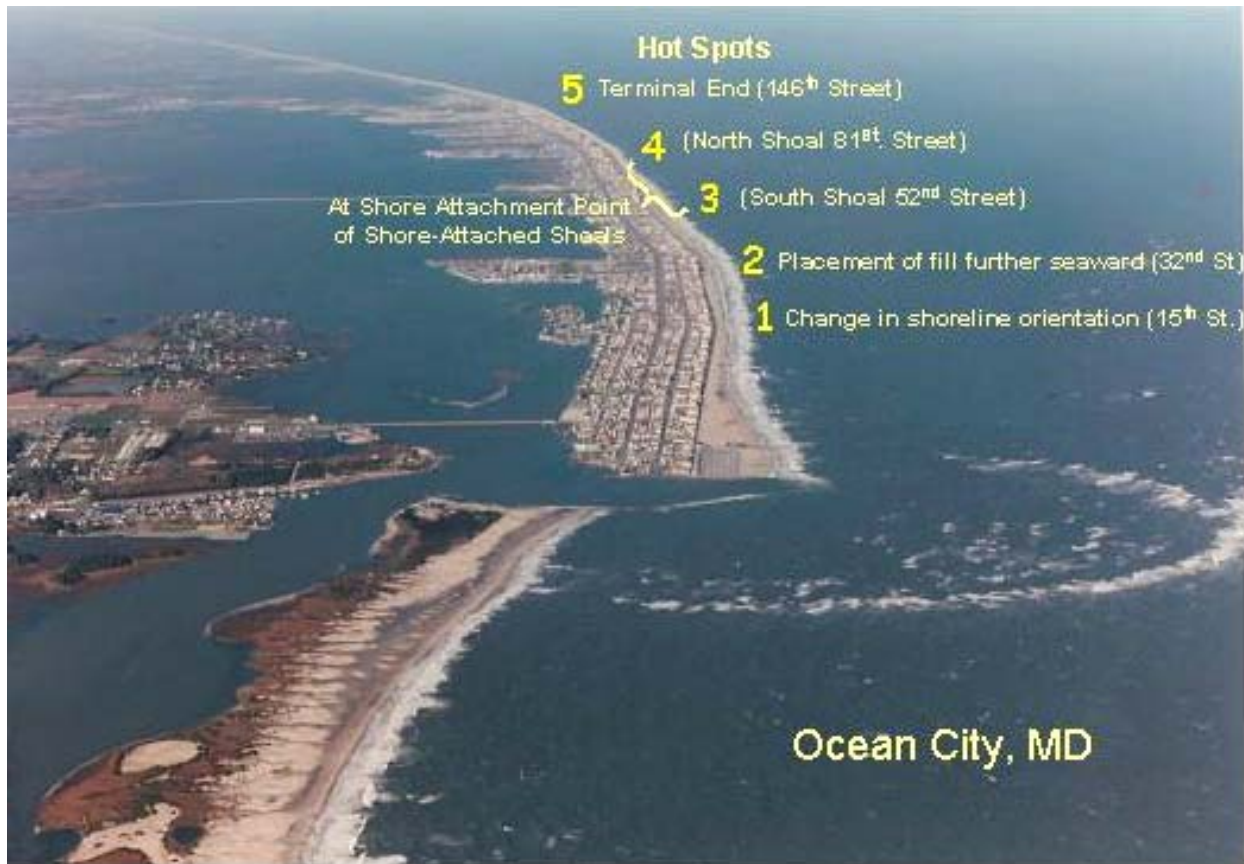
Figure 8. Location of the five hot spots along Atlantic coast of Maryland (Ocean City) Shoreline Protection project (Stauble and Bass 1999)

The project developed five unanticipated hot spots at 15th, 32nd, 52nd, 81st, and 146th Streets (Figure 8). These hot spots were identified by analysis of beach profile data using shoreline position and fill volume change and percent of fill remaining analysis (Stauble and Kraus 1993; Stauble 1994; Stauble and Bass 1999) and wave refraction studies (Smith and Ebersole 1997). The 15th Street hot spot is identified as an orientation change in the shoreline from northwest to a more northward facing shoreline. Extra fill was placed during renourishment and as more sand was placed

with each renourishment this hot spot area lost less sand volume. The 32nd Street hot spot was caused by a seaward encroachment of the upland property onto the beach requiring fill to be placed seaward of the adjacent beaches to maintain the design requirement of a uniform fill template. As more sand was retained on the profile with each successive fill this hot spot area has also become less of a problem. The hot spots at 52nd and 81st Streets are suspected to be a function of wave focusing at the landward end of two shore-attached shoals. End loss at the northern terminal end of the project at 146th Street is the location of the final hot spot. Overfilling the hot spot areas and back passing sand by truck from the inlet area have been the remedial steps taken. These areas have required 49 percent of the total fill volume placed. Sand eroded from these hot spots has been deposited in a series of “cold spots” where excess sand volume was measured above the fill volume placed and the shoreline is consistently seaward of the adjacent areas (Figure 9). These cold spots suggest a complex 3-D sediment transport mechanism between the hot and cold spots. Even with the high frequency of storms, there has been no upland structure damage since the project inception in 1988. The fill volume requirements have also decreased over time with the renourishment now focused only in the hot spot areas.

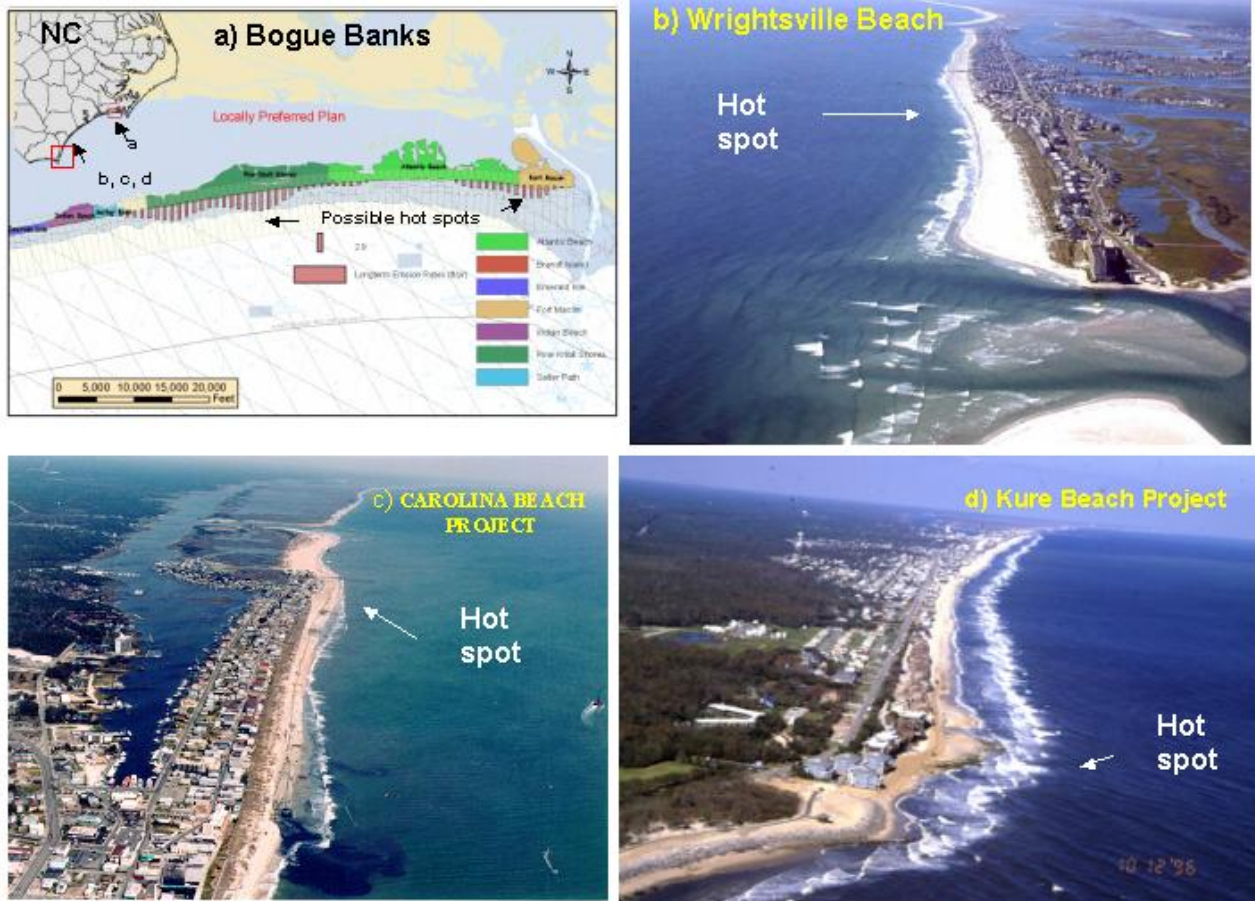
Figure 10. Hot spot location at four projects along the North Carolina coast (a) Bogue Banks at Morehead City near Cape Lookout, NC, (b) Wrightsville Beach, (c) Carolina Beach and (d) Kure Beach just north of Cape Fear, NC (courtesy of John McCormick, Wilmington District)

**North Carolina Projects.** There are four beach nourishment or inlet navigation dredged material disposal projects that have hot spots along the North Carolina coast, and two proposed project areas that have known existing hot spot locations. The four constructed projects are located in the central and southern part of the coast. Net drift is from north to south and east to west depending on the shoreline orientation along this cusped shoreline.

The Bogue Banks area, located about 16 km (10 miles) west of Cape Lookout, has a program that places some sand dredged from the navigation channel at Beaufort Inlet and Morehead City Harbor onto the beach about every 4 years at Fort Macon State Park and Atlantic Beach west of the inlet. A beach-fill project for Bogue Banks is presently in the feasibility study phase. Shoreline change studies indicate a hot spot along the Fort Macon and Atlantic Beach shoreline close to the inlet and at Pine Knoll Shores (Figure 10a). It is suspected that erosion in the Fort Macon area is related to the wave refraction over the ebb shoal and a drift reversal into the inlet resulting in local shoreline erosion. Further study is needed to verify if this is a hot spot and its cause. Another area of erosion is indicated some 6,096 m (20,000 ft) to the west in Pine Knoll Shores. Little study has been done, so a cause is undetermined at this time.

A beach nourishment project exists along the town of Wrightsville Beach, located along the North Carolina coast about 40 km (25 miles) north of Cape Fear. The project began in the mid-1960s and extends about 4.8 km (3 miles) north from Masonboro Inlet to Mason Inlet with a 4-year renourishment cycle. One hot spot is associated with this project and appears to be related to the location of the historic Wrightsville Inlet that is now closed (Figure 10b). There are no modifications to fill placement due to the hot spot. The underlying geology of this former inlet may influence the location of this hot spot.

The Carolina Beach nourishment project and the adjacent Kure Beach nourishment project have existed since 1964. The Carolina Beach project involves a 3-year renourishment cycle. Both projects are located south of Carolina Beach Inlet. A hot spot is located just south of a fishing pier where a seawall has been constructed to protect the upland development (Figure 10c). Remedial efforts include placement of more renourishment sand in the hot spot area. The Kure Beach hot spot is located at the southern end of the project where a natural coquina beachrock outcrop is exposed (Figure 10d). This rock exposure results in longshore drift interruption and possible localized wave focusing to create a hot spot as well as a shoreline orientation change to the south. A rock revetment

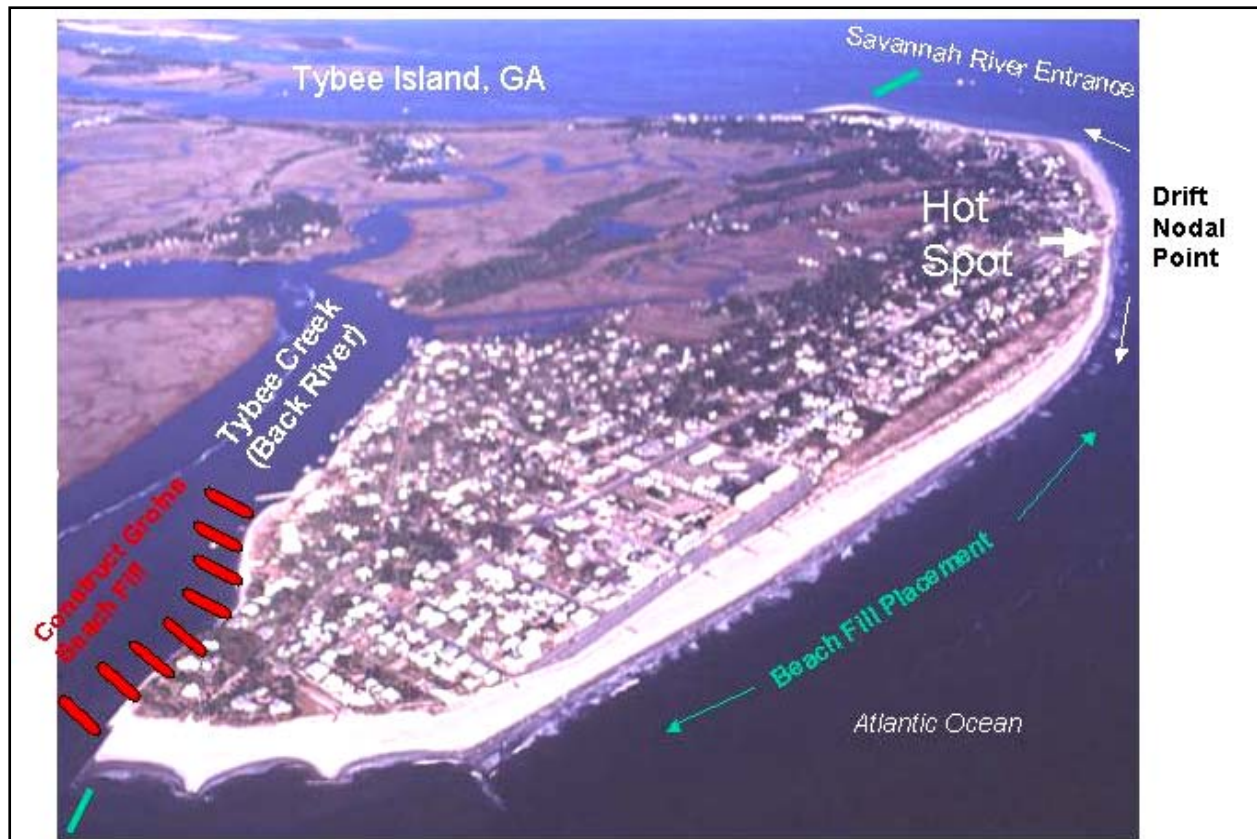
Figure 16. Hot spot location and nodal point at Tybee Island, GA, fill project (courtesy of Carol Abercrombie, Savannah District)

One hot spot has formed on the ocean beach in the middle of the island (Figure 16). The suspected cause of this hot spot is a change in shoreline orientation, which is also a nodal point for sediment transport north into the Savannah River entrance and south to Tybee Creek (Back River) inlet. The hot spot has become a sediment source for transport in both directions away from the placement area. Methods taken to addressing the hot spot include the construction of groins at the hot spot area to interfere with the longshore transport, lengthening and sand tightening of the north end groin to trap sand from loss into the Savannah River entrance, increasing the beach's berm width and increasing the frequency of renourishment to provide a sand supply to this nodal point.

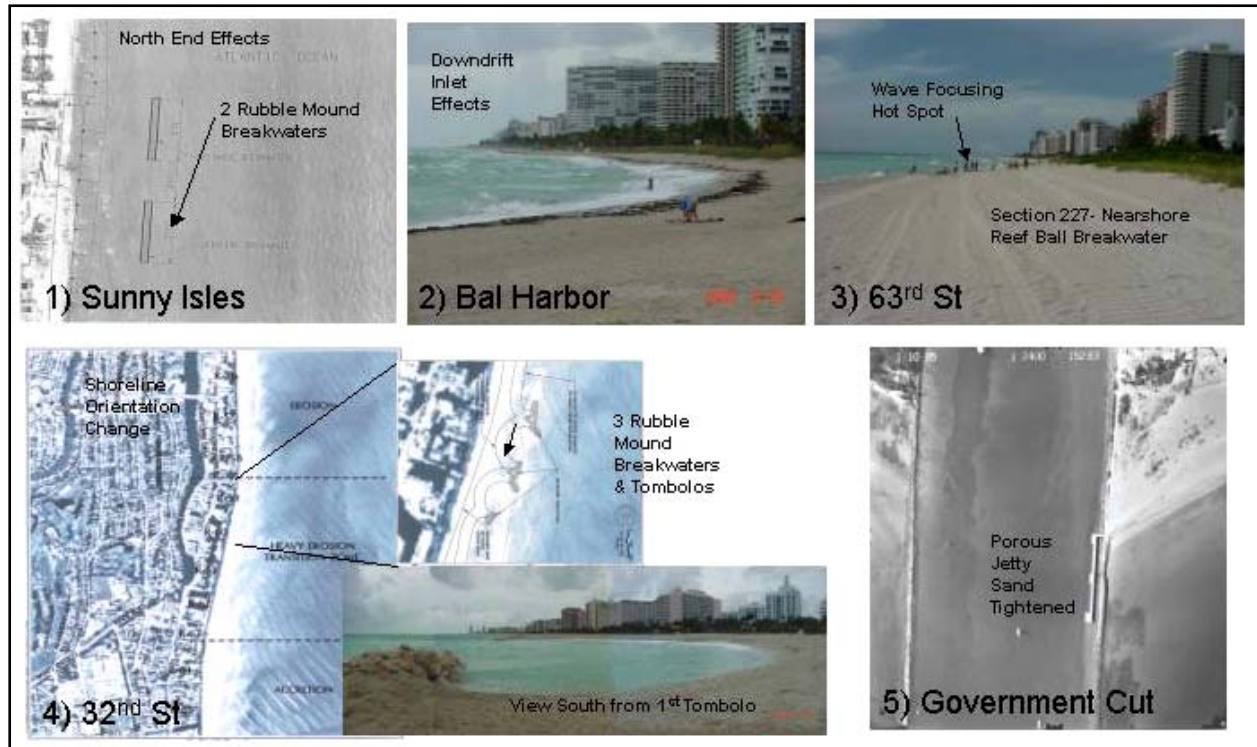
Figure 18. Photographs of the five hot spots along Dade County, FL, fill with remedial measures taken or planned

Mitigation of the Dade County hot spots involves a variety of approaches (Figure 18). The Sunny Isles end effect hot spot was mitigated by construction of two submerged rubble-mound breakwaters in 2001. These breakwaters were designed to lower the wave energy as it approached the beach and reduce end losses to the north. The breakwaters have performed well and are holding the fill material in place. No mitigative action has been taken at the south jetty of Bakers Haulover Inlet at this time. The hot spot at 63rd Street will become part of the National Shoreline Erosion Control Development and Demonstration Program (Section 227) project to construct and test innovative shore protection

devices. A submerged nearshore reef ball breakwater will be constructed at this site in the near future to lower the wave energy and soften focusing of waves by the irregular bottom caused by natural coral reefs prevalent in the nearshore at this site. At the 32nd Street site, three emergent nearshore coral rock rubble-mound breakwaters were constructed in 2002, at the hot spot location where the shoreline orientation changes from north/south to more northeast/southwest. Tombolos (a sand tongue attachment between the breakwater and beach) were constructed by trucking fill sand from further down the beach, back updrift and placing it behind each of the breakwaters. At the present time the breakwater/tombolo configuration has stabilized the hot spot associated with the local shoreline orientation change. The natural coral reef in this area enhances wave focusing resulting in

the shoreline orientation change. At Government Cut entrance, the north jetty has been sand tightened, which has eliminated the loss of fill material into Government Cut, and has stabilized the beach width at this southern terminus of the project.

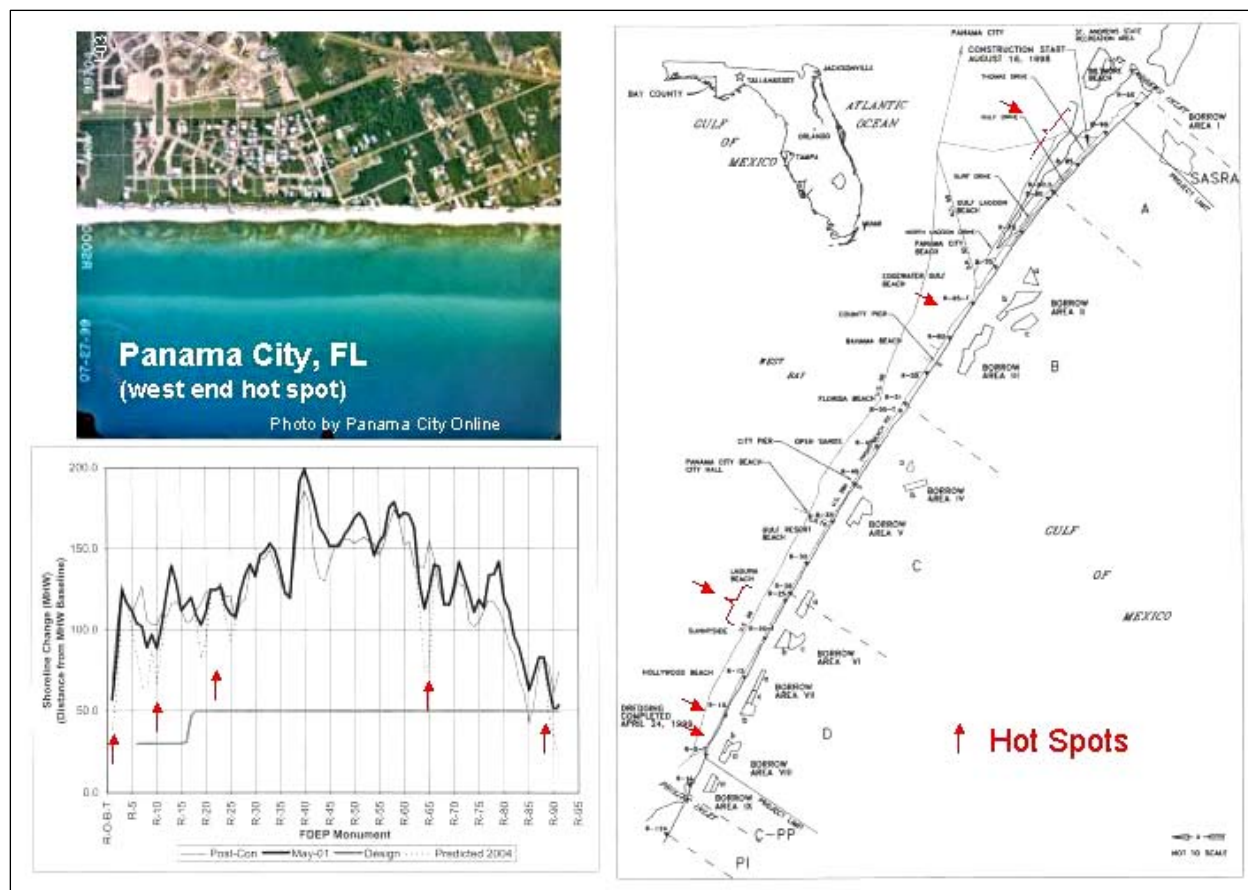
Figure 19. Aerial photograph (from Bay County, FL) location map and shoreline change analysis (courtesy of Linda Lillycrop, Mobile District) of the five hot spots along Panama City, FL, fill project

**Panama City, FL.** The Panama City beach fill was completed in 1999. Panama City is located on the Gulf Coast of the Florida panhandle (Figure 19). The fill covered 28 km (17.5 miles) from Phillips Inlet on the west to Panama City Harbor Entrance (St. Andrews Inlet) on the east. Monitoring of shoreline change and volume of fill remaining was achieved through a series of beach profiles located at the Florida Department of Environmental Protection (DEP) monuments R-1 to R-91. Five hot spots were found at the west end of the project at R-4 and at R-10 to R-12 in Hollywood Beach, R-19 to R-25 in Sunnyside Beach, around R-60 to R-65 in Panama City, and at the east end between R-84 to R-91 near St. Andrews Inlet (from Coastal Planning and Engineering 2002).

No definitive cause was given for these hot spots, but the borrow areas were close to the beach in several areas along this project and may have resulted in fill placed on the beach moving back to the borrow trough areas. A general correlation exists between the locations of the borrow areas and the hot spots. Wave refraction over these borrow holes, as well as other irregular bathymetry, may have caused wave focusing at the hot spots, but no studies have confirmed this as yet. Both terminal ends also measured losses.

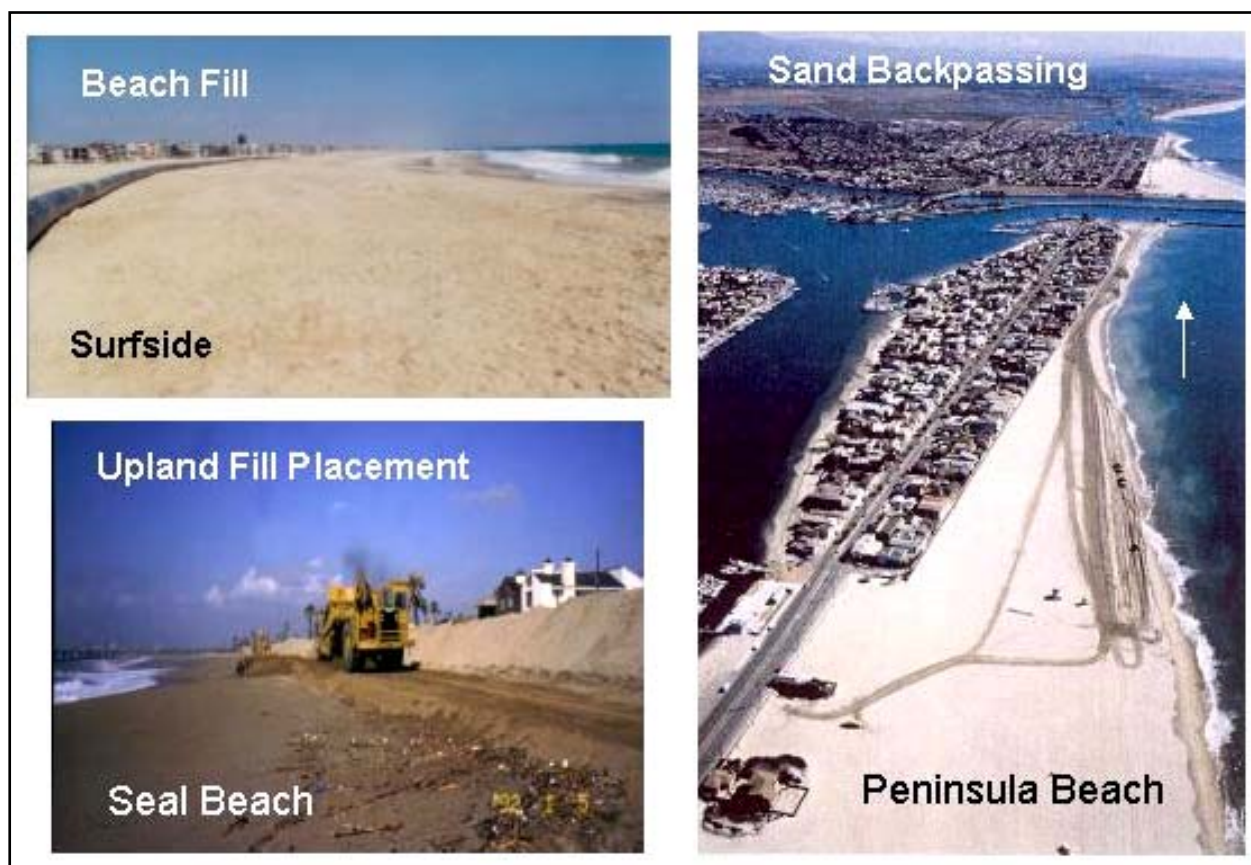
Figure 22. Photographs of mitigation for the three hot spots along southern California coast showing pipeline fill renourishment from offshore borrow area at surfside, upland fill placement at Seal Beach and truck haul backpassing at Peninsula Beach (courtesy of Chuck Mesa, Los Angeles District)

Mitigation for the hot spots include periodic beach nourishment using a nearshore borrow area for Surfside (Figure 22). The first fill was placed using an upland source in 1964. The project has been filled 11 times since then on a roughly 6-year renourishment cycle, with the last one in May 2002. The dredging of the channel into the Naval Weapons Station was used as a source of fill on two occasions, but most of the fill has been from nearshore borrow areas. The hot spot at Seal Beach was nourished with an upland fill source that was moved by rail to the coast and truck hauled onto the beach by local interests. Local interests filled the Peninsula Beach hot spot with sand back-passed by truck from the wide beach to the west back to the beach adjacent to the jetty.
